1 NORTH CHAPEL - GROUND FLOOR PLAN
 Scale: 1:50

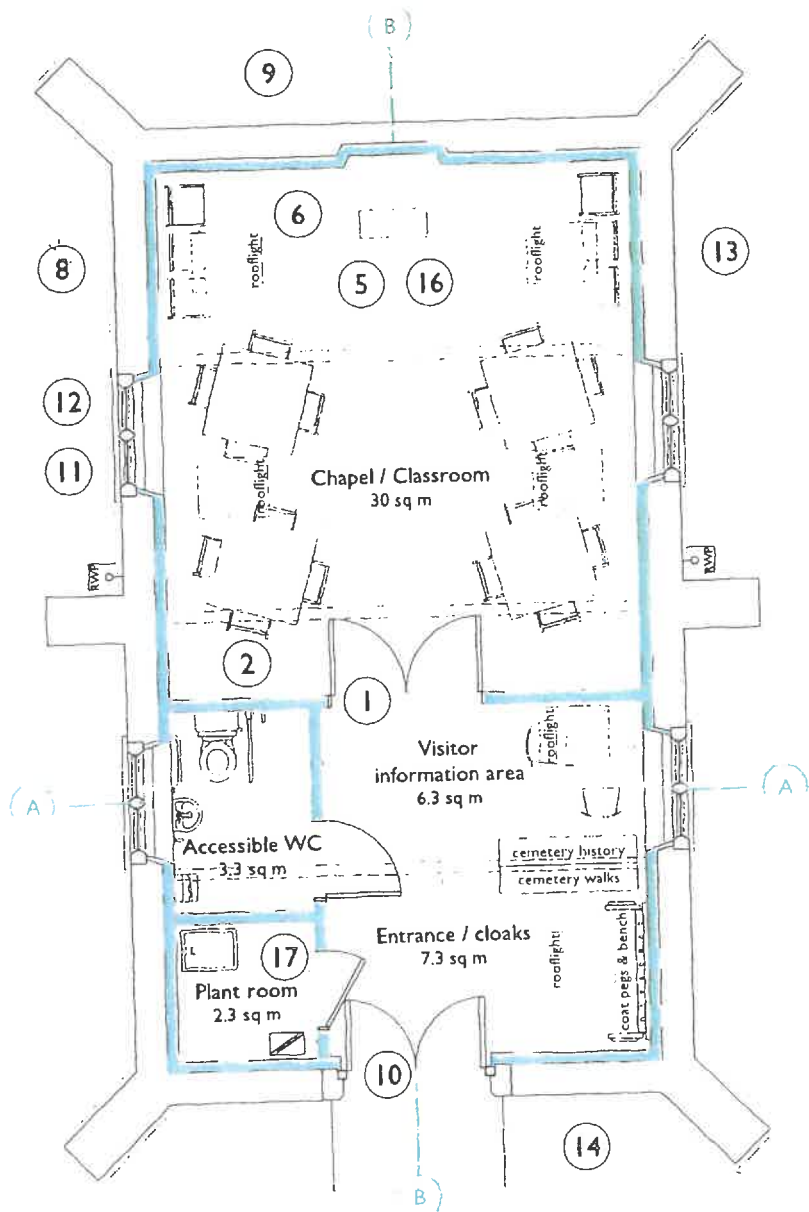
- ① New timber partition or screen to create a multi-purpose private chapel / classroom / function space for civic society talks with new lockable double doors.

- ② New timber partition to create new area open to the general public including: entrance / cloaks area, fully DDA compliant WC, plant room / cleaners store and visitor information area for cemetery history and guided walks.

- ③ Clean off moss and vegetation growth from roof coverings and masonry buttress cappings.
- ④ Existing ceilings to be removed; new rooflights to be installed to provide natural daylight into the Chapel and Entrance area, roof to be insulated with breathable insulation and finished with traditional lime plaster.

- ⑤ Existing rotten and structurally unsound timber suspended floors to be removed and replaced with breathable limecrete floor insulated with recycled glass insulation. New flag stone floor coverings to be laid.

- ⑥ Existing timber panelling to be taken down and all loose and friable decoration and plaster including any cement/gypsum based plaster to be removed from historic wall fabric. Walls to be insulated with breathable natural insulation and finished with traditional lime plaster.

- ⑦ Existing cast iron rainwater goods to be repaired, cleaned out, and connected into new soakaway or mains drain.
- ⑧ All overgrown / ingrowing vegetation to masonry walls to be removed. Rake out C21st cement mortar repairs, remove redundant cast-iron ventilation grilles, cut out and replace badly spalled / fractured masonry and repoint all open joints in hot-lime mortar.

- ⑨ Existing cement render to be carefully hacked off the historic wall fabric, spalled and fractured masonry to be replaced and new traditional hot-lime breathable render to be applied to East gable wall.

- ⑩ Existing timber double entrance doors to be repaired, new weather proofing thresholds, draught proofing strips and door locking mechanism to be installed.

- ⑪ Clean off and remove any spalled / friable areas of stone window surrounds and mullions. Defective stone to received specialist masonry repairs.
- ⑫ Existing leaded windows to be retained and repaired where overgrown vegetation has caused damage.

- ⑰ Replace and upgrade existing electrical systems to comply with current regulations, including; new internal lighting, electric heating and hot water systems.
