I NORTH CHAPEL - GROUND FLOOR PLAN
Scale: 1:50

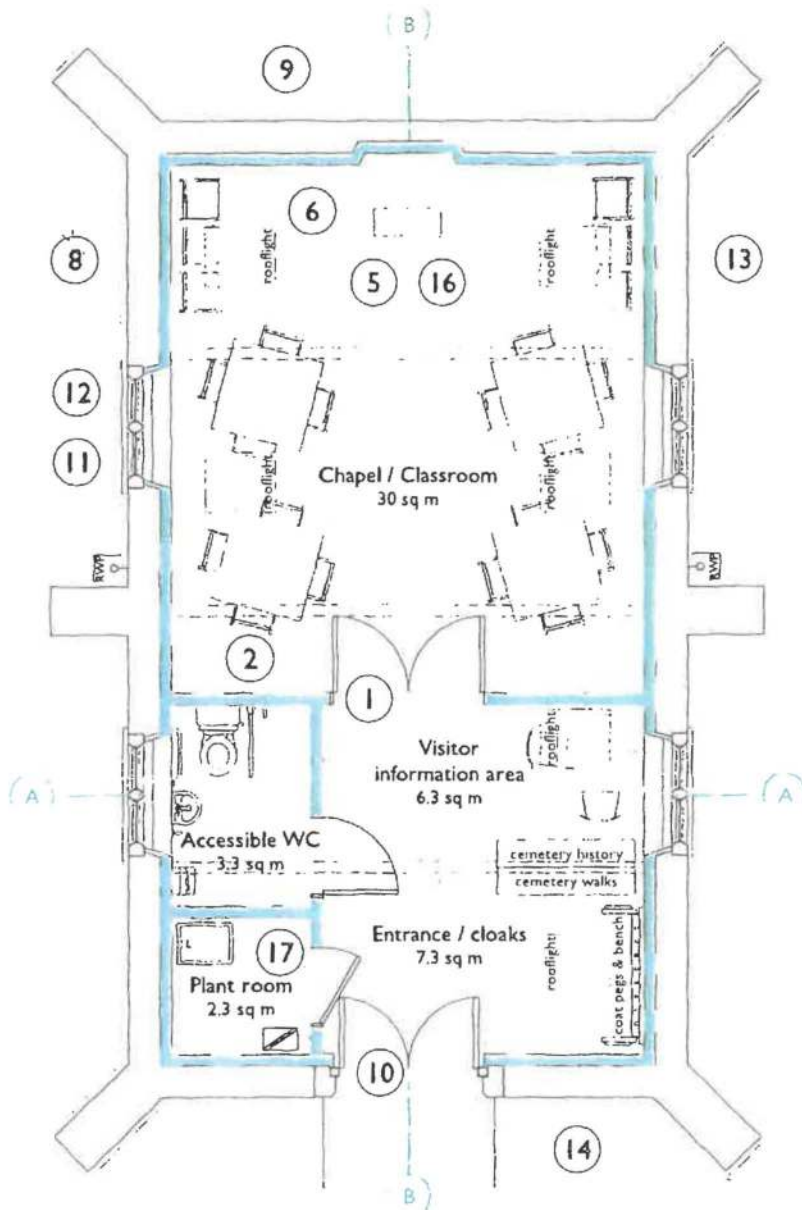
- ① New timber partition or screen to create a multi-purpose private chapel / classroom / function space for civic society talks with new lockable double doors.

- ② New timber partition to create new area open to the general public including: entrance / cloaks area, fully DDA compliant WC, plant room / cleaners store and visitor information area for cemetery history and guided walks.

- ③ Clean off moss and vegetation growth from roof coverings and masonry buttress cappings.
- ④ Existing ceilings to be removed; new rooflights to be installed to provide natural daylight into the Chapel and Entrance area, roof to be insulated with breathable insulation and finished with traditional lime plaster.

- ⑤ Existing rotten and structurally unsound timber suspended floors to be removed and replaced with breathable limecrete floor insulated with recycled glass insulation. New flag stone floor coverings to be laid.

- ⑥ Existing timber panelling to be taken down and all loose and friable decoration and plaster including any cement/gypsum based plaster to be removed from historic wall fabric. Walls to be insulated with breathable natural insulation and finished with traditional lime plaster.

- ⑦ Existing cast iron rainwater goods to be repaired, cleaned out, and connected into new soakaway or mains drain.
- ⑧ All overgrown / ingrowing vegetation to masonry walls to be removed. Rake out C21st cement mortar repairs, remove redundant cast-iron ventilation grilles, cut out and replace badly spalled / fractured masonry and repoint all open joints in hot-lime mortar.

- ⑨ Existing cement render to be carefully hacked off the historic wall fabric, spalled and fractured masonry to be replaced and new traditional hot-lime breathable render to be applied to East gable wall.

- ⑩ Existing timber double entrance doors to be repaired, new weather proofing thresholds, draught proofing strips and door locking mechanism to be installed.

- ⑪ Clean off and remove any spalled / friable areas of stone window surrounds and mullions. Defective stone to be repaired by specialist masonry repairs.

- ⑫ Existing leaded windows to be retained and repaired where overgrown vegetation has caused damage.
- ⑬ New french drain to be installed around perimeter of chapels, connected into a new soakaway or mains drains.

- ⑭ New external lighting scheme to light pathways and exterior of building to be installed.
- ⑮ New bat / bird boxes to be installed at high level around perimeter of chapel.

- ⑯ New breathable decoration to be applied to all wall and ceiling surfaces.
- ⑰ Replace and upgrade existing electrical systems to comply with current regulations, including; new internal lighting, electric heating and hot water systems.
